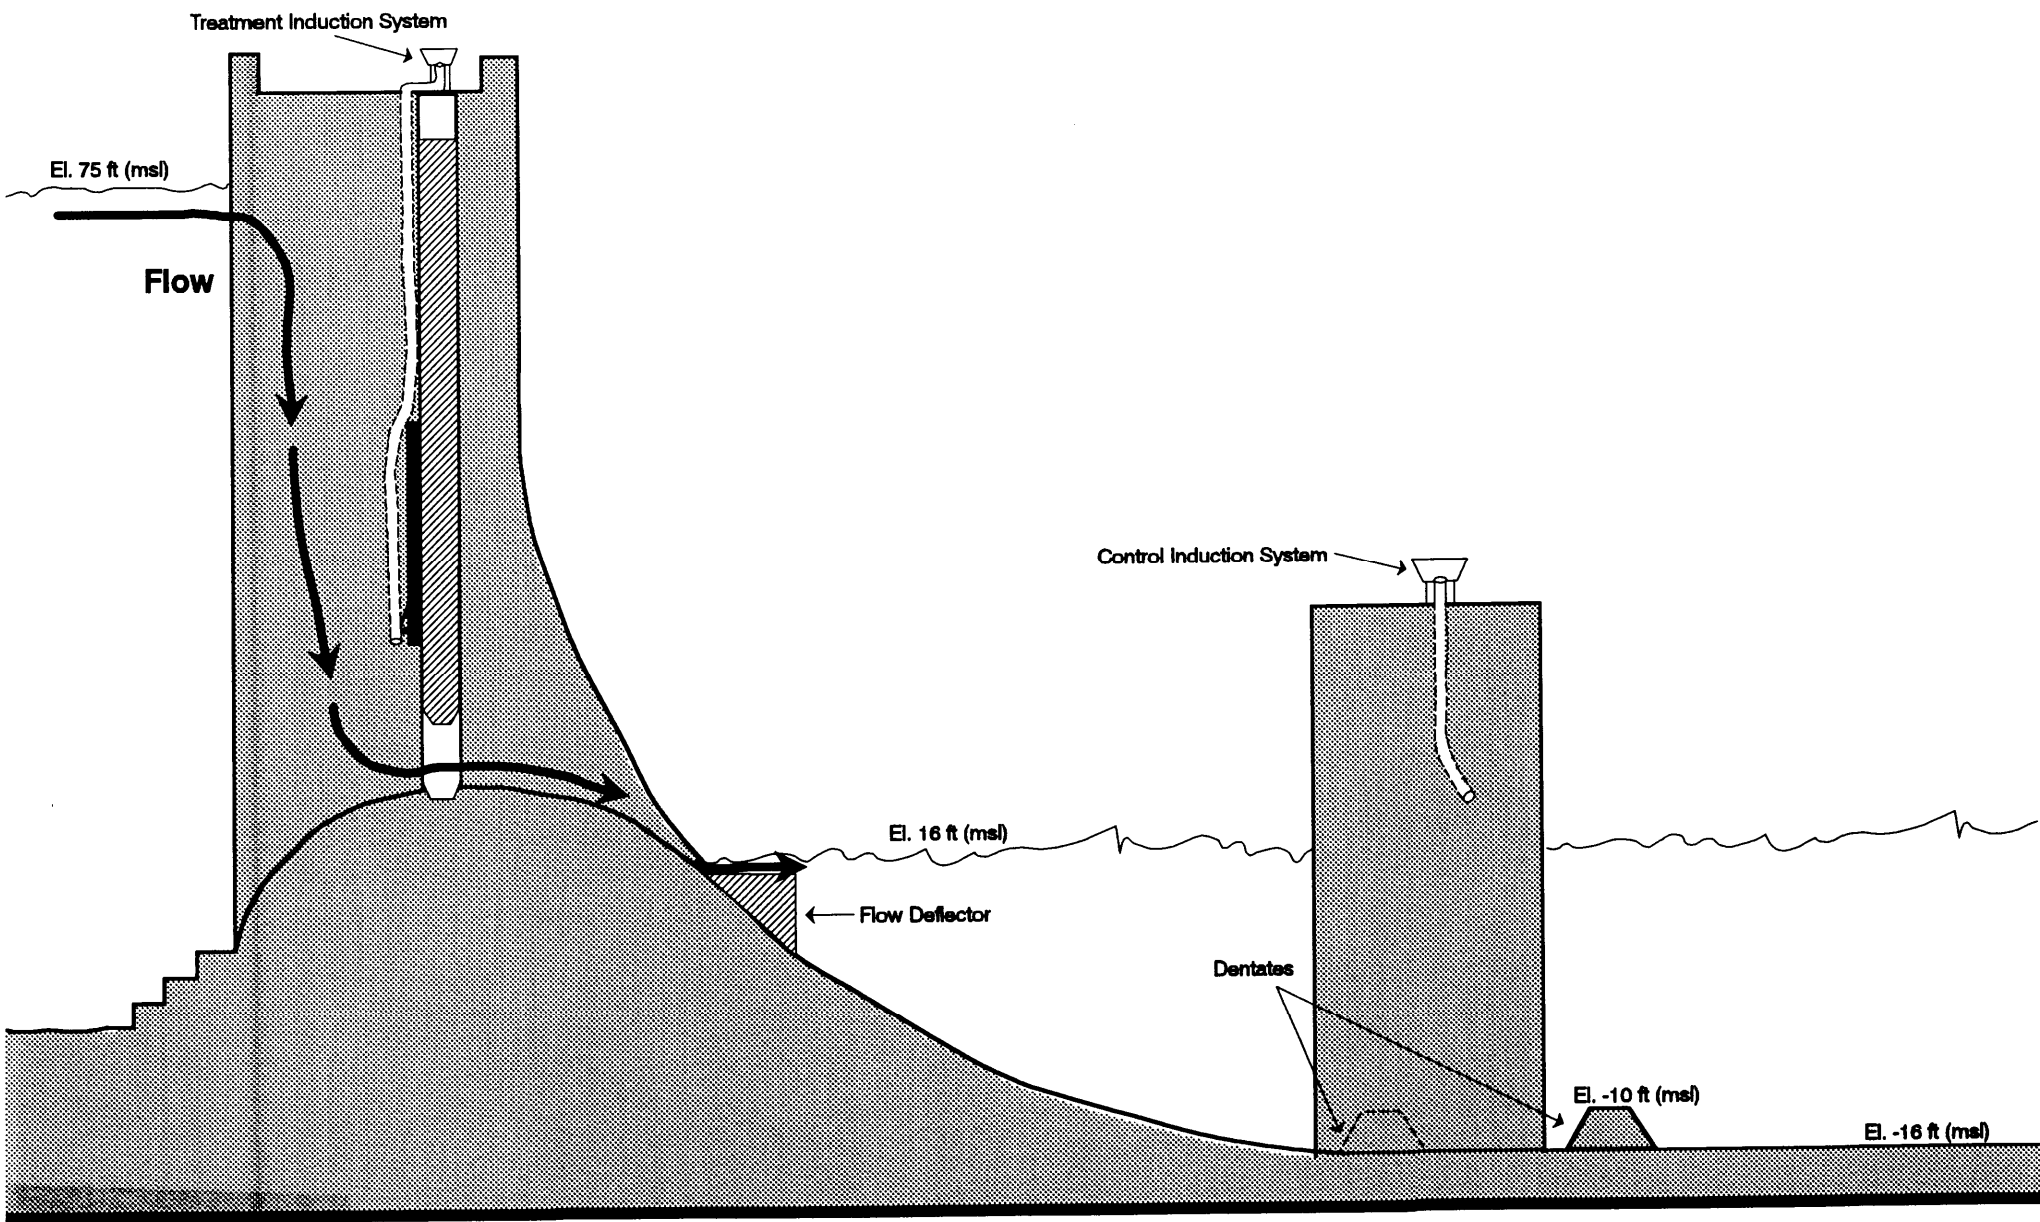
Figure 1-3

Schematic of a spillbay with a flow deflector installed, showing treatment and control fish release locations, at Bonneville Dam.
